# Manhole Inspection Summary

Manhole # S41U\_\_013MH

Insp Date: **10/10/08 11:34 AM**

**Location** Address: **1465 key hw.**

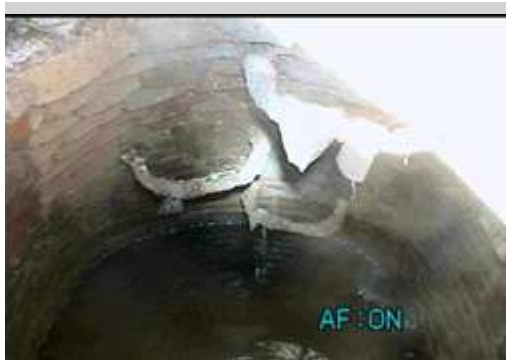
Defect 2

Count: **3** Missing: **0** ☒ **Corroded**

☒ **Evidence Of Surcharge** Depth: **5** (ft.) ☐ Active Surcharge Present

cor. steps, evidence of surcharge

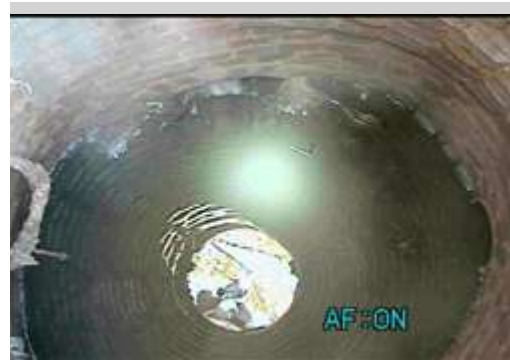
Defect 3

Condition: ☐ Sound ☐ Cracked ☐ Root Intrusion ☐ Deteriorated ☐ Leaks ☒ **Debris**

Bench & Channel debris

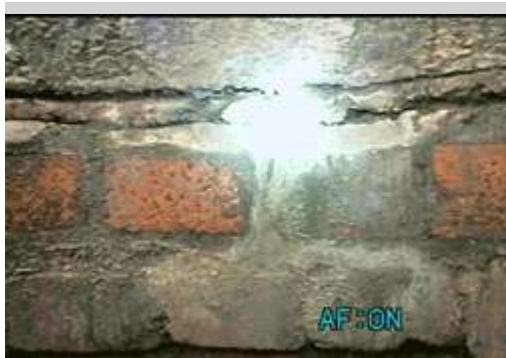
Defect 1

Condition: ☐ Sound ☐ Cracked ☐ Root Intrusion ☐ Loose Brick ☒ **Deteriorated**

deteriorated chimney/frame adj

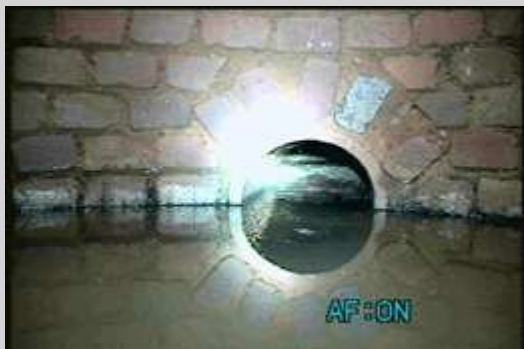
3 O'Clock Inflow

Deposits: ☐ None ☐ Mud ☐ Sludge ☒ Debris ☒ Grease

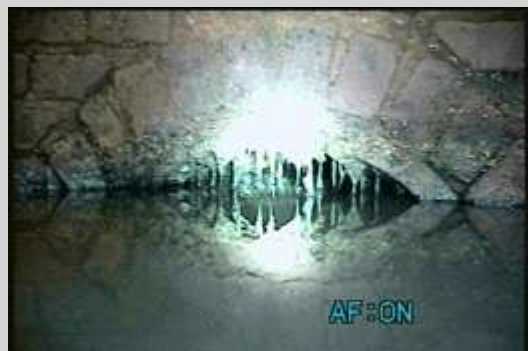
6 O'Clock Inflow

Deposits: ☐ None ☐ Mud ☐ Sludge ☒ **Debris** ☒ **Grease**
